# ANALYSIS OF ARRAY COMPONENTS RECOVERED AT ST. CROIX, VI

Research & Engineering Department

May 1977

NAVTORPSTA Report 1332, *Analysis of Array Components Recovered  
at St. Croix, VI*

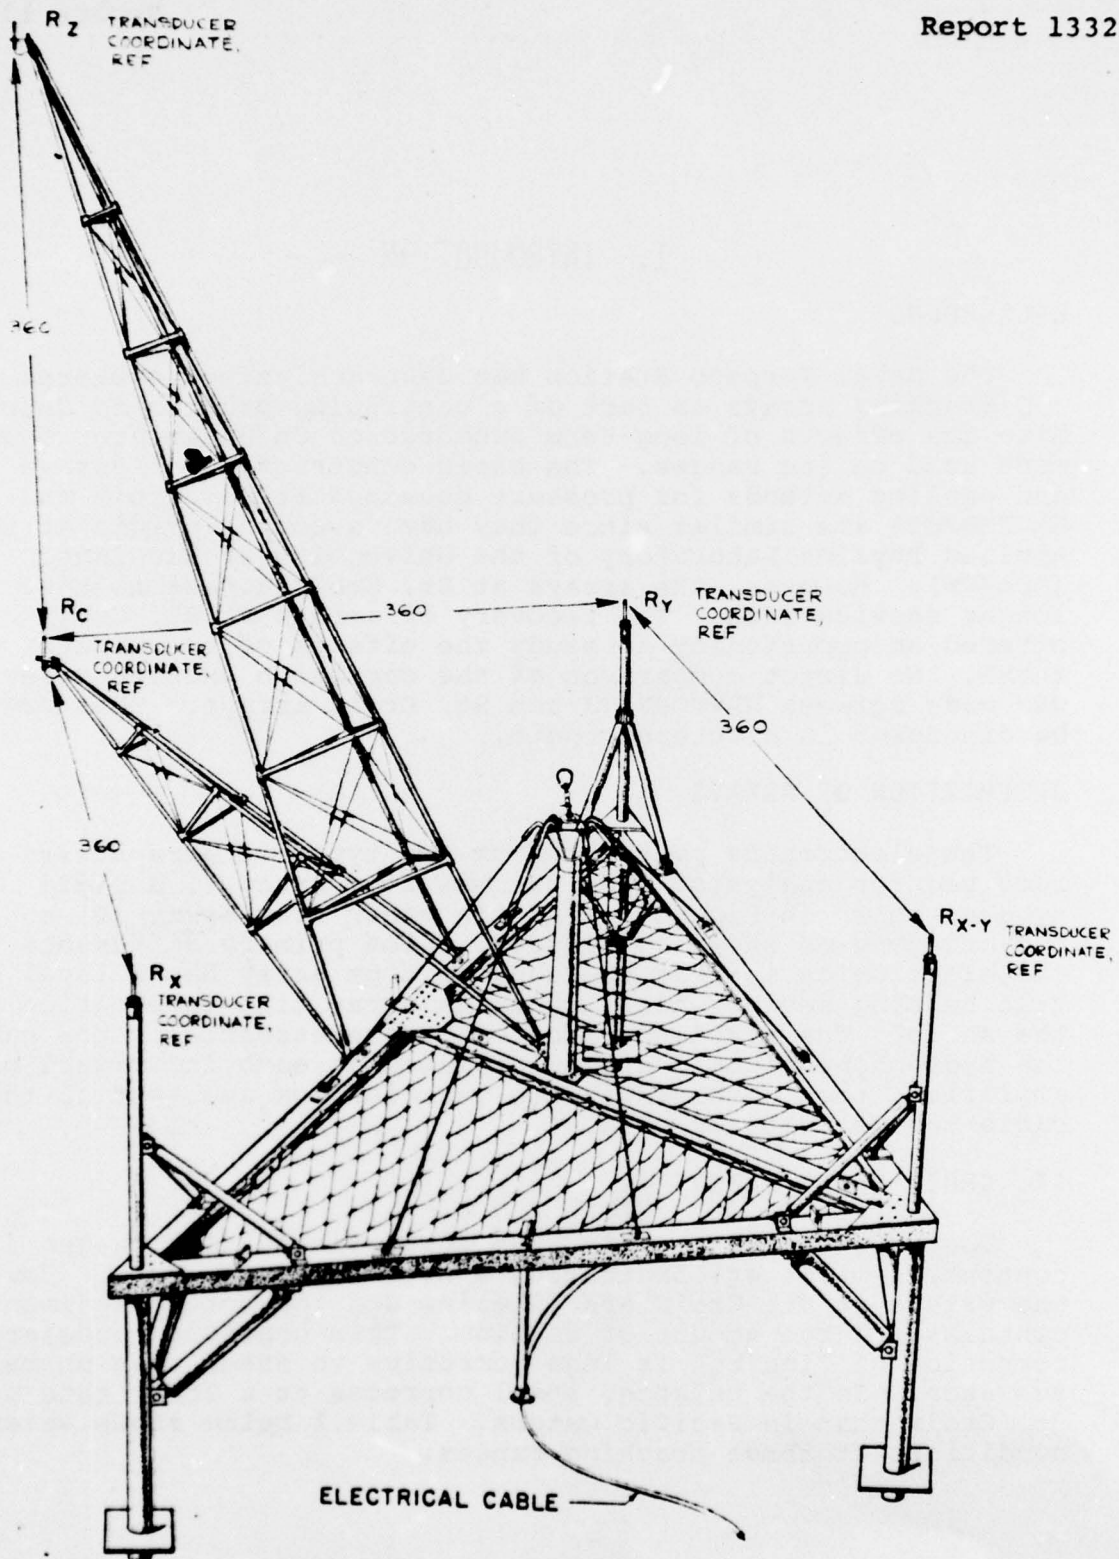
Figure 1. Rigid Array, St. Croix

The electronics packages from two types of arrays were received for analysis. One set was from array 7, a rigid type as shown in Figure 1; and the other from array 10, a buoyant type as shown in Figure 2. The primary difference in the electronics is that the buoyant type array has a level or tilt sensing device which transmits array tilt information to the shore. The tracking electronics are essentially the same: the hydrophone signals are multiplexed at each individual pre-amplifier, then combined at the junction box and sent up the cable to the computer site.
